## OPENING UP DAR ES SALAAM GATEWAY BY WIDENING KIMARA - KIBAHA ROAD TO EIGHT LANES - AN OVERVIEW OF PROJECT IMPLEMENTATION

Published by: National Construction Council

# APPRAISAL OF RUTTING IN ASPHALT LAYERS: A CASE OF THE MOROGORO - GAIRO ROAD IN TANZANIA

## OPENING UP DAR ES SALAAM GATEWAY BY WIDENING KIMARA-KIBAHA ROAD TO EIGHT LANES - AN OVERVIEW OF PROJECT IMPLEMENTATION

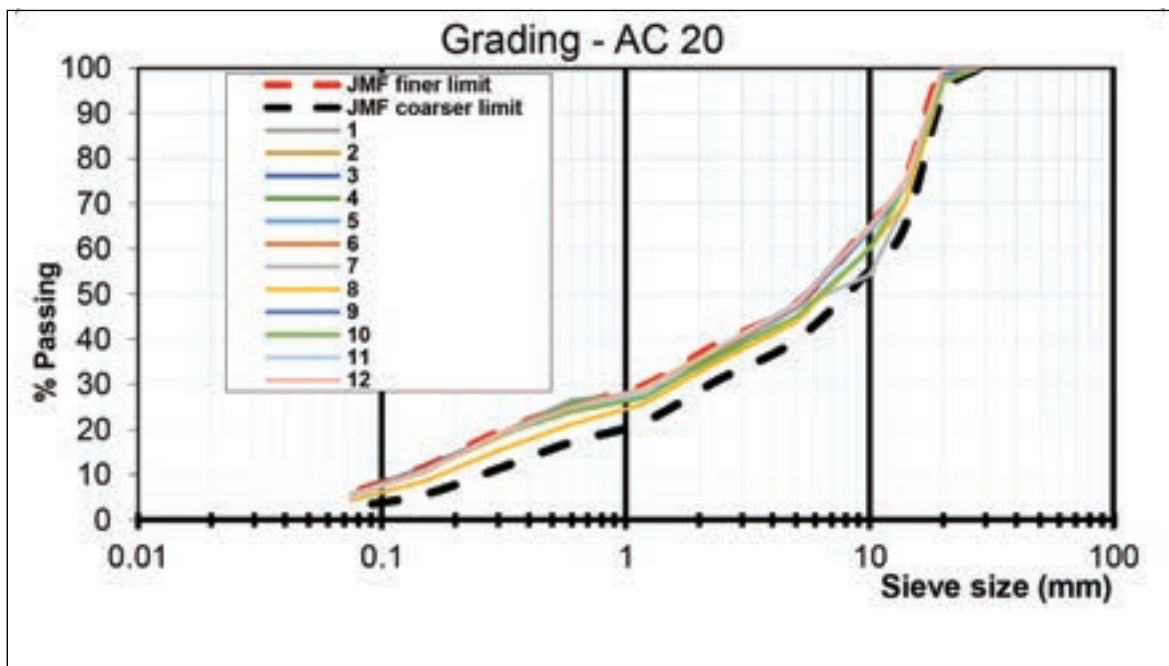
Particle size distribution properties of aggregates used in the asphalt layer are summarised in Figure 2.

Figure 2: Recovered Aggregate Grading - Asphalt

According to the results, the grading curves are generally as per the job mix specification. Aggregate provides more of load bearing characteristics of the mix than bitumen. According to [13] aggregate gradation is an effective factor for rut and fatigue resistance of asphalt mixture. Occurrence of excessive rutting in the field despite non departure from the specified grading suggests limitations in the specifications used for the aggregate, hence attributable to the prevailing distresses.

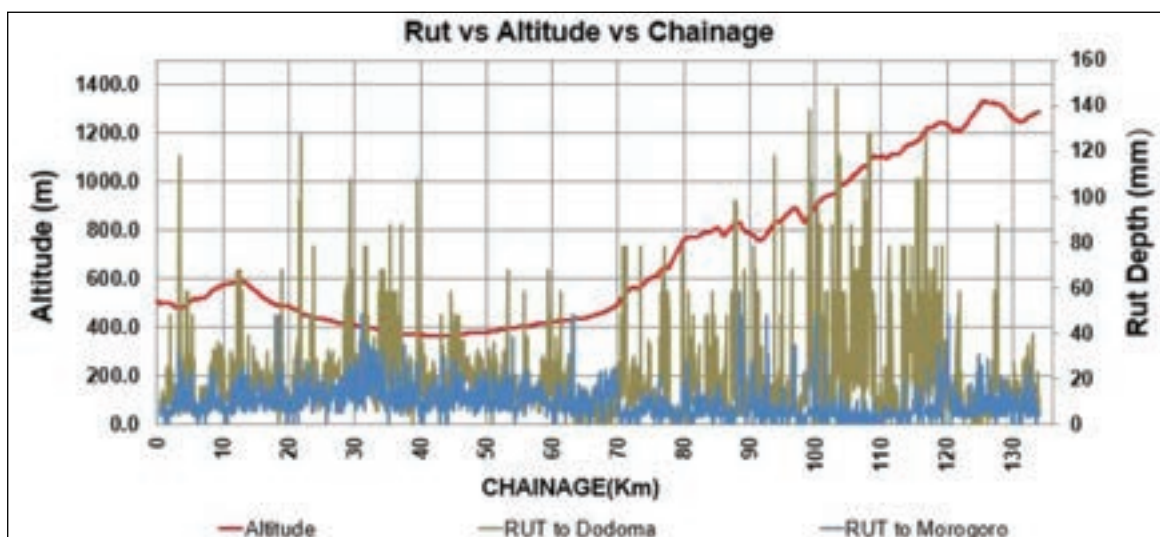
Rutting was more pronounced on the climbing lanes and slow-moving traffic since the heavy loaded vehicles tend to slow down hence increasing loading rates, which translates to more permanent deformation. Figure 4 shows the results of rut depth measured along the road section plotted against chainage and altitude.

Figure 4: Altitude and Rut depth vs Chainage

The altitude graph (Figure 4) shows that the direction towards Dodoma is generally uphill, with climbing lanes at around km 2+000 to 4+000 and 70+000 to 120+000. Rutting is more pronounced on these sections, with values measuring up to 140 mm towards Dodoma (heaviest lane) and 58 mm towards Morogoro as shown in Figures 4 and 5.

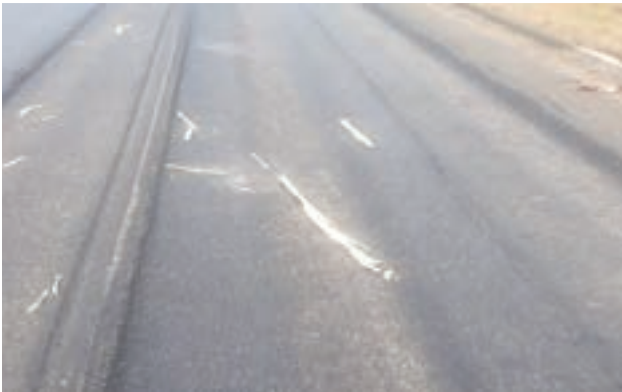
The sections that had more pronounced rut had other more distress such as patches, cracks, alligator cracks and potholes. The dominant distress was rutting (Figure 5).

Figure 5: Severe rutting (Direction to Dodoma)

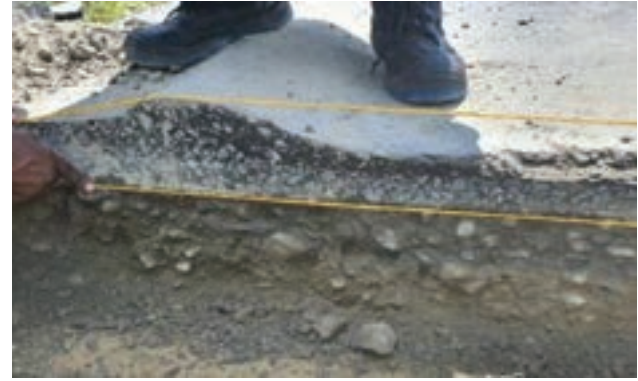
Figure 7: Typical Test Pit

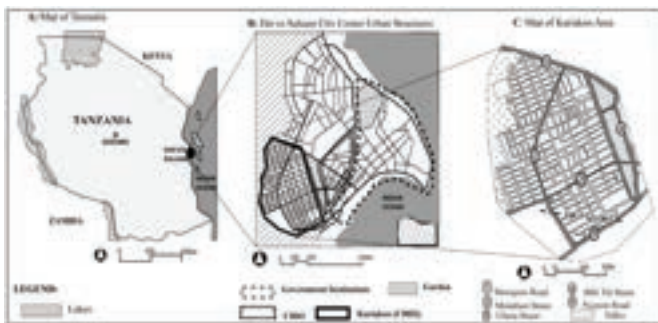
Figure 2: Map of the Kariakoo Area showing the Study Locality

Kariakoo covers about 1.96 km<sup>2</sup> of land which is bound by Morogoro Road to the North, Bibi Titi Street to the East, Nyerere Road to the South and Shaurimoyo Street and Uhuru Street as well as Msimbazi Valley to the West. The name of Kariakoo is a Kiswahili word that originated from the words 'Carrier Corps' because the Kariakoo market was used as a military depot for Carrier Corps during WWI. Historically, Kariakoo was a small village that was frequently raided by slave traders where thousands of people were kidnapped and forced into slavery and sent to America, Europe and Arabian countries.

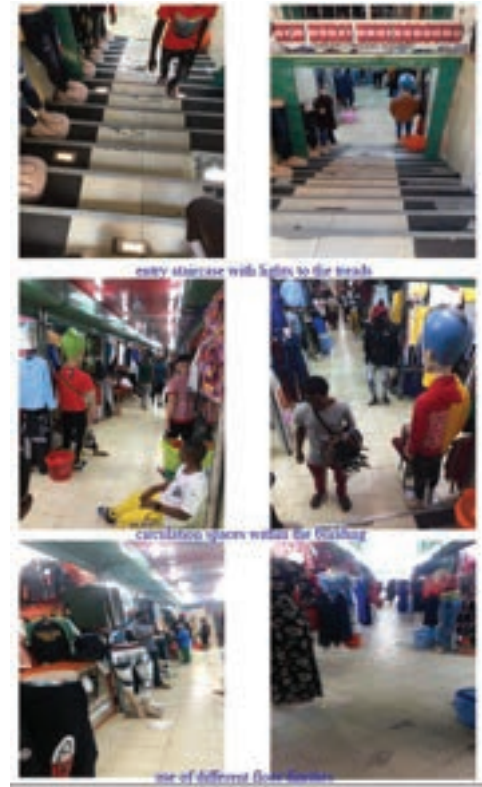
Figure 4: Entrances to Underground Commercial Spaces

converted into underground spaces for shopping activities (Figure 4). As already mentioned, the interest of this study was to investigate the qualities of these spaces in multiple aspects. It was found that in the study area, there are about 40 buildings with basement commercial spaces. Some of these have inlets and outlets while others have only inlets which are also used as outlets. Some of these buildings have their basements connected. Basement spaces can be put in different categories depending on the type of activities being conducted. Just over a half (52%) of all the basement buildings are associated with businesses that involve selling clothing materials; 17% are associated with selling of shoes; 6% sell musical and electronic appliances, 25% are associated with a variety of other isolated things that could not be grouped, e.g. fruits, food products, spare parts etc. Selling and buying was the most dominant activity in both basement and elevated spaces.

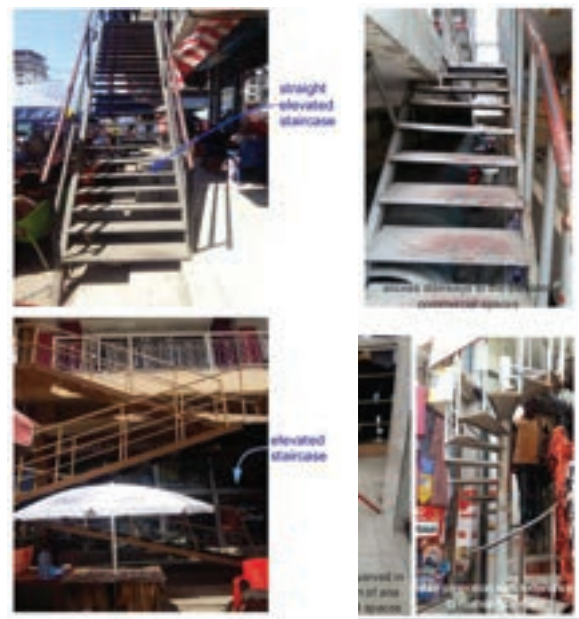
Figure 5: Entrances to Elevated Commercial Spaces

Elevated commercial spaces were established in Kariakoo from around the year 2004 due to a demand for shopping activities (Swai & Deguchi, 2009b). These are commercial spaces (shops) located in the first floor and are accessed by staircases located on the outside of the buildings (Figure 5). Most of the staircases seem very temporary due to the nature of materials used and the location of these staircases, some of them jutting into the streets. Most of these spaces are used for selling clothes, shoes and electronic products.

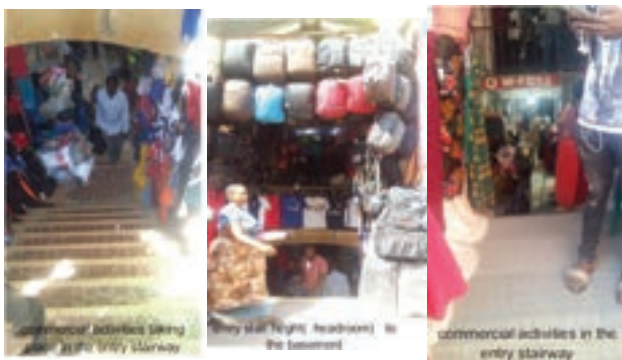
**Figure 8: Display of Goods at Entrances Blocking Air Circulation**

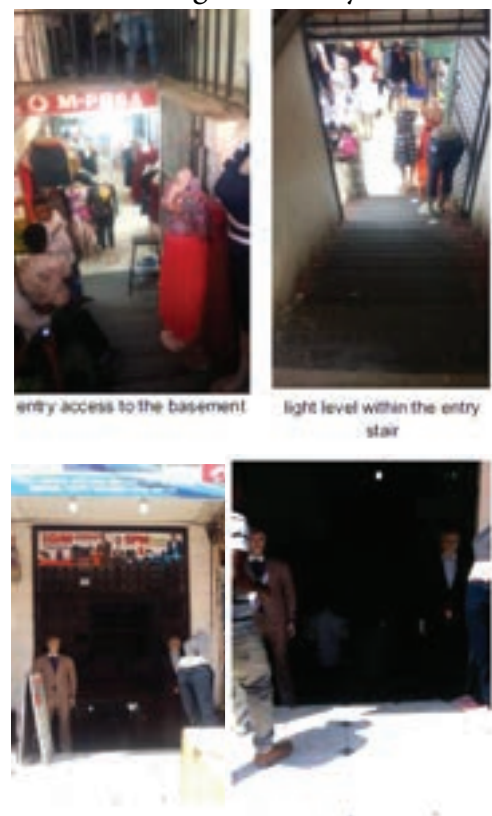
The variations show that users may not be aware of proper lighting levels, as they cannot determine adequate amount of light with respect to the activities they do. No basement has adequate access to daylight, as they depend on artificial lighting. Readings were taken during a power cut; and readings in 68% of the basements were below 20 lux while in places where generators were used had 32% reading between 100 and 120 lux. Here again, there was competition between light and noise due to generators running from every other building.

Figure 10: Light Conditions in Various Basement Places

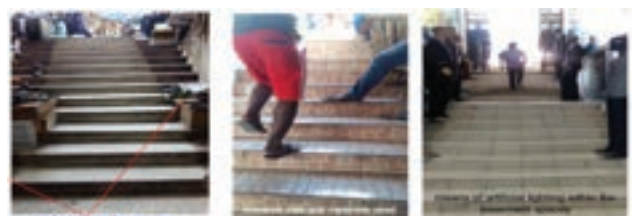
Figure 12: Entrances and Exit Routes in Underground Spaces

One customer X, complained about the congestion: “Every time I come to these underground spaces I cannot carry my stuff because there are so many people and manoeuvring one’s way is very tedious. You have to struggle a lot to succeed to be attended by a shop owner”. Also, another shop owner in a different building was complaining: *“How long shall we keep stuffing ourselves and goods in these tiny and unventilated spaces? I would prefer a bigger space; the problem is that rent is so high that we can’t make any profit if we take up bigger spaces”*. The two submissions testify to the fact that neither customers nor sellers in underground commercial spaces were satisfied with the size of spaces.

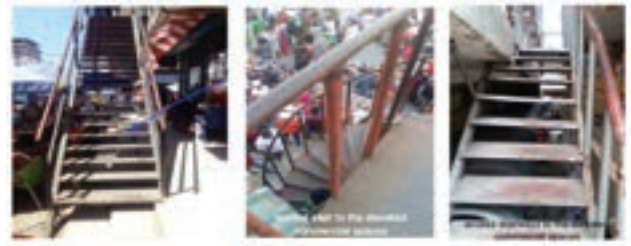
In terms of adequacy of stair size in the elevated commercial spaces, data shows that less than a quarter (21%) of the users opined that the stair size was adequate, whereas almost three quarters (71%) complained that the stairs were too small for customer movement, especially when there were many people. Only 8% said the

stair sizes were just enough (Figure 13).

Figure 13: Stairs Leading to Elevated Commercial Spaces

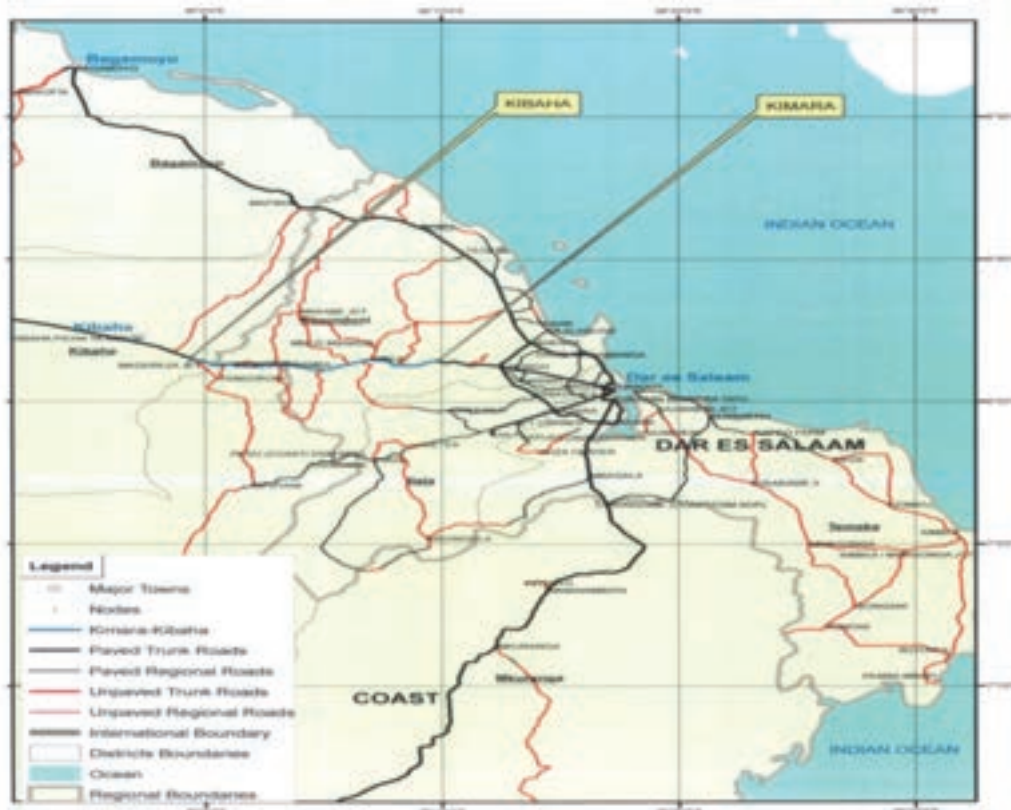
Fig. 1: City of Dar es Salaam with Project Road, Feeder and Ring Roads

The Government initiated a programme of upgrading regional roads to bitumen standard within the City of Dar es Salaam in order to alleviate traffic congestion along trunk roads. Based on Dar es Salaam Transport Master Plan, construction projects involving several feeder and ring roads commenced in phases in order to divert the traffic approaching the City through Morogoro road to those roads. Figure 1 shows the project road as well as feeder and ring roads before they were constructed.

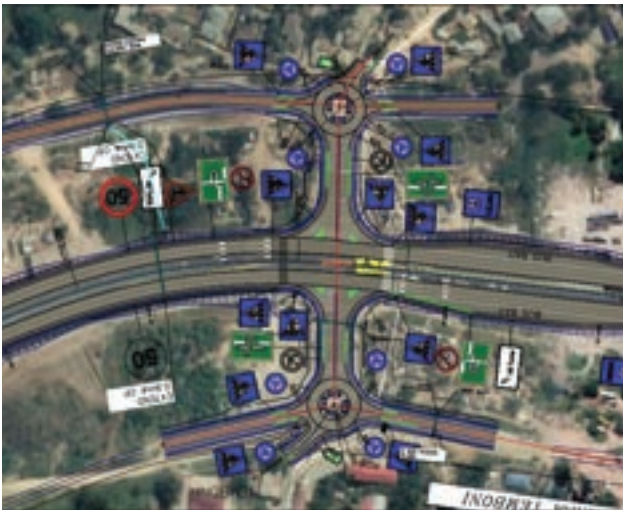
**Fig. 4: Bowtie Traffic Junction Constructed at Mbezi-Temboni**

These measures have ensured smooth riding of vehicles and have minimized the number of traffic conflict zones along the road. Typical Bowtie intersection as constructed at Mbezi-Temboni is shown in Figure 4 while a Jughandle rumps combined with Bowtie are constructed at Mloganzila Overpass Bridge as shown in Figure 5.

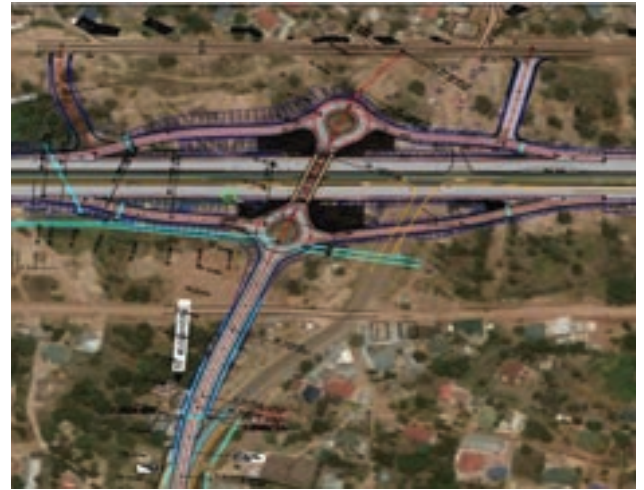
**Fig. 5: Jughandles and Bowtie Intersection at Mloganzila Overpass Bridge**

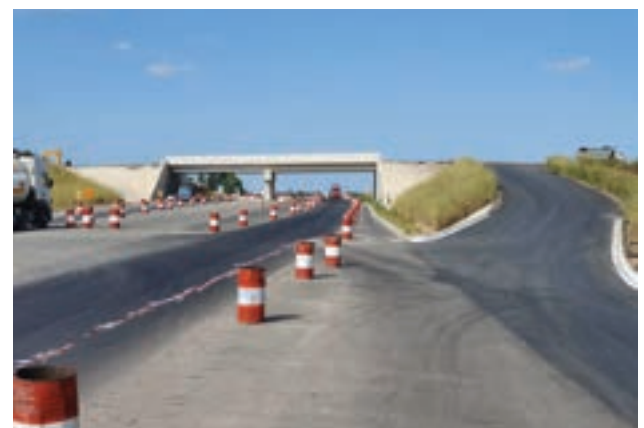
**Fig. 6: Traffic Jughandle Junction as Constructed at Mloganzila Overpass Bridge**

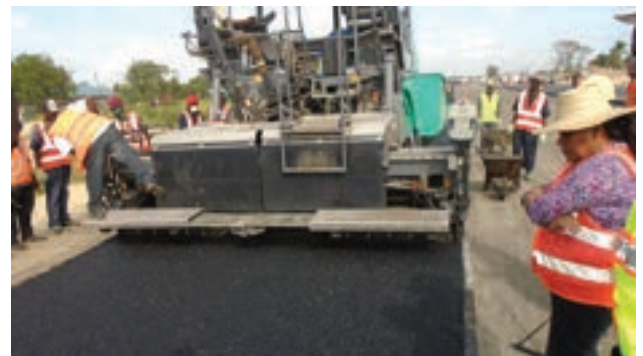
Fig. 8: Laying of Sperpave SP 37.5 mm layer

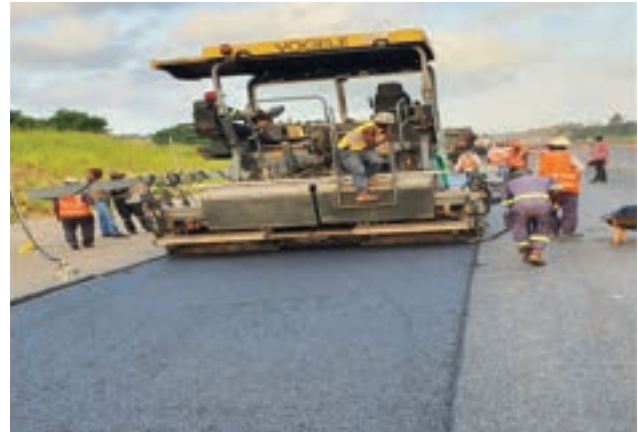
**Fig. 9: Laying of Finishing Layer (SMA 12.5), 50mm Thickness**

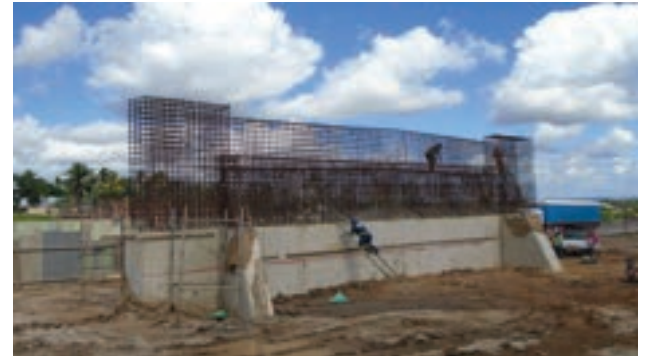
**Fig. 10: Construction of Abutment for Kibamba Bridge**
